# Proper Instrument Care: The “Myth” of Retipping

Sherry Burns, RDH, MS\* • Judy Zack Bendit, RDH, BS†

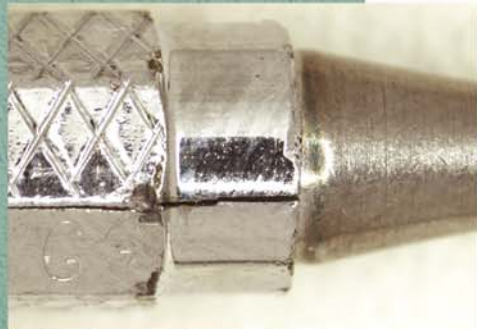
Figure 1. Crack in instrument handle.

Instrument fabrication is a complex process, not simply just placing a tip into a handle. There are issues of balance, alignment, unique characteristics inherent in each company's individual designs, and special procedures to ensure the strength and integrity of the junction of the turning (which consists of the entire shank and blade, commonly referred to as tip) inside the handle. This is the major safety issue in the retipping process. When a turning (ie, tip) is removed from a handle, it must be forcibly extracted to break the inherent mechanical and chemical locking features of the original instrument. Small, almost microscopic, cracks may occur in the hub of the handle. Lateral pressure by the clinician during the scaling process may snap the turning out of the weakened handle. In addition, the microcracks are a portal of entry for the microleakage of organisms and debris into the hollow handle. When a new turning is force-fit into the weakened handle, further damage may result. The original dimensions at the hub of the handle may have been altered, making it impossible to replicate the precision-fit with small gaps occurring at this critical junction. The handle is the least expensive segment of an instrument. Is it worth using an old handle that has been compromised in the refurbishing process? Why would a professional knowingly pay for such risks? Remember, the FDA has warned the end-users by requiring specific labeling.

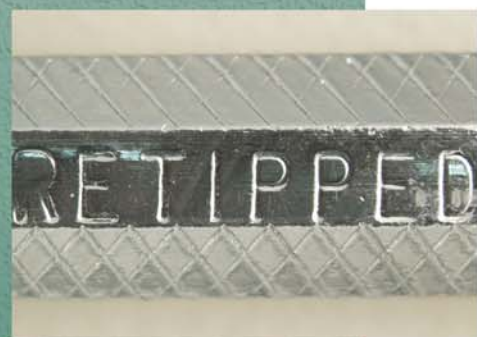
Figure 2. Retipping of an instrument
